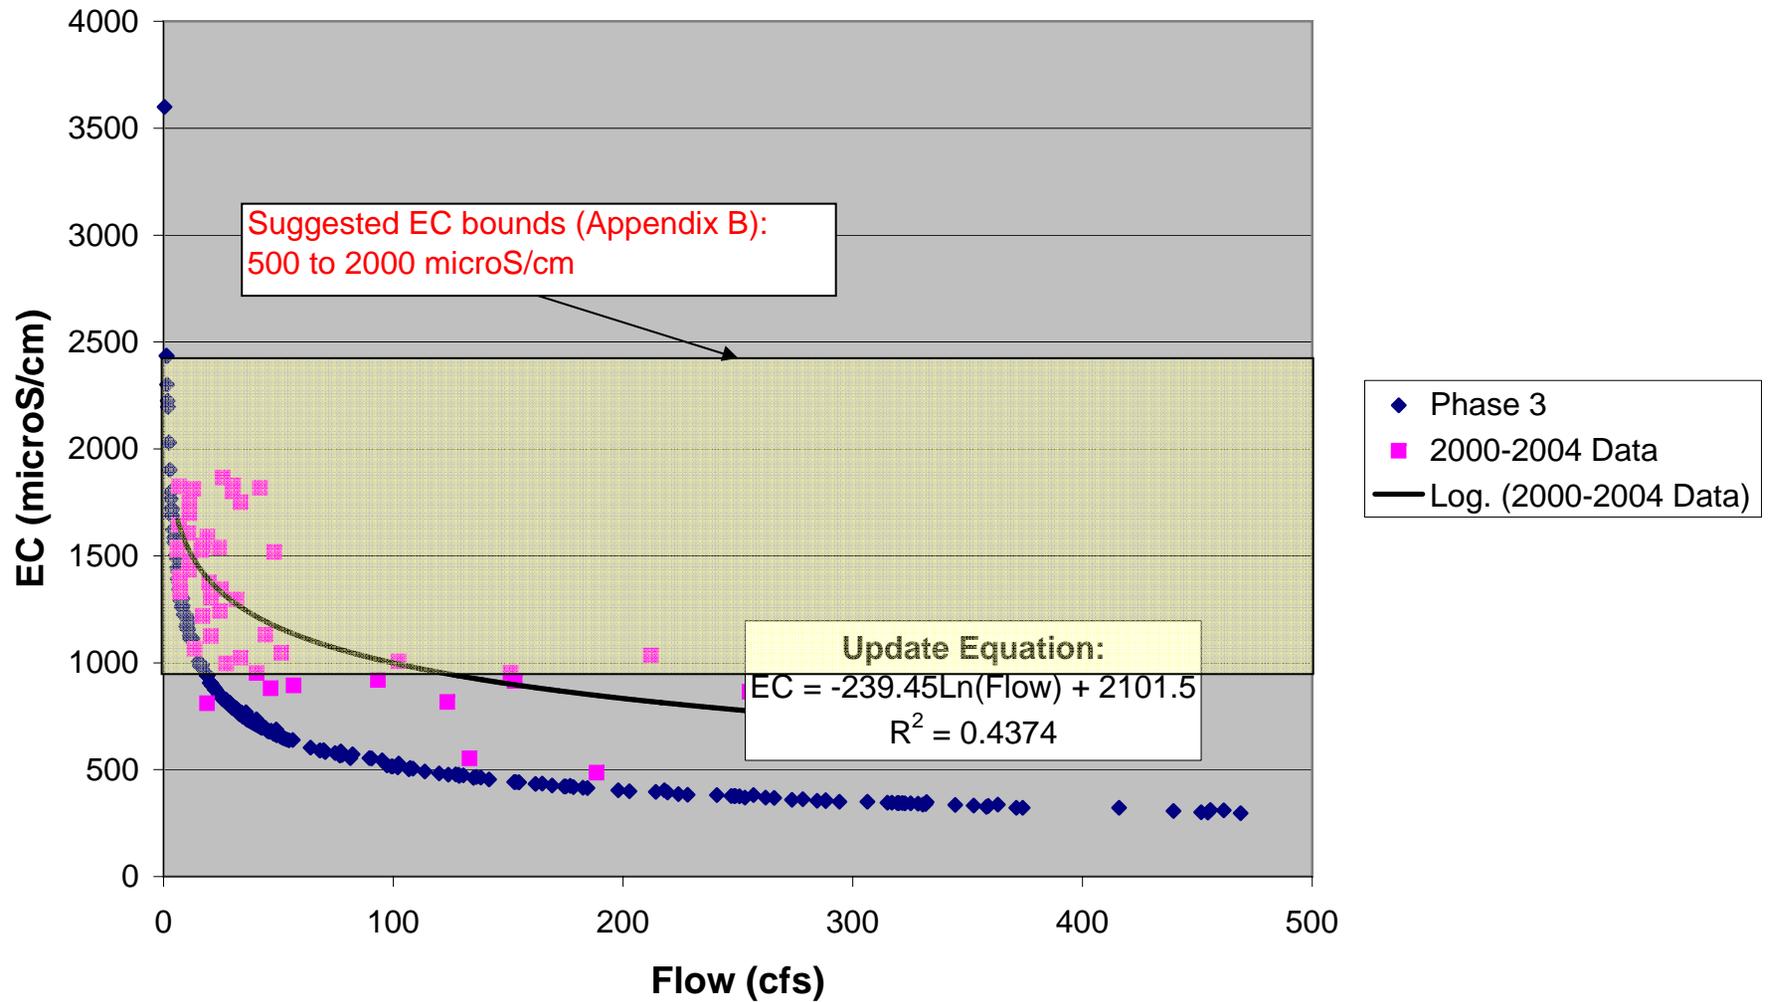
Figure 2.1
Flow-EC Boundary Condition for San Joaquin River at Lander Ave

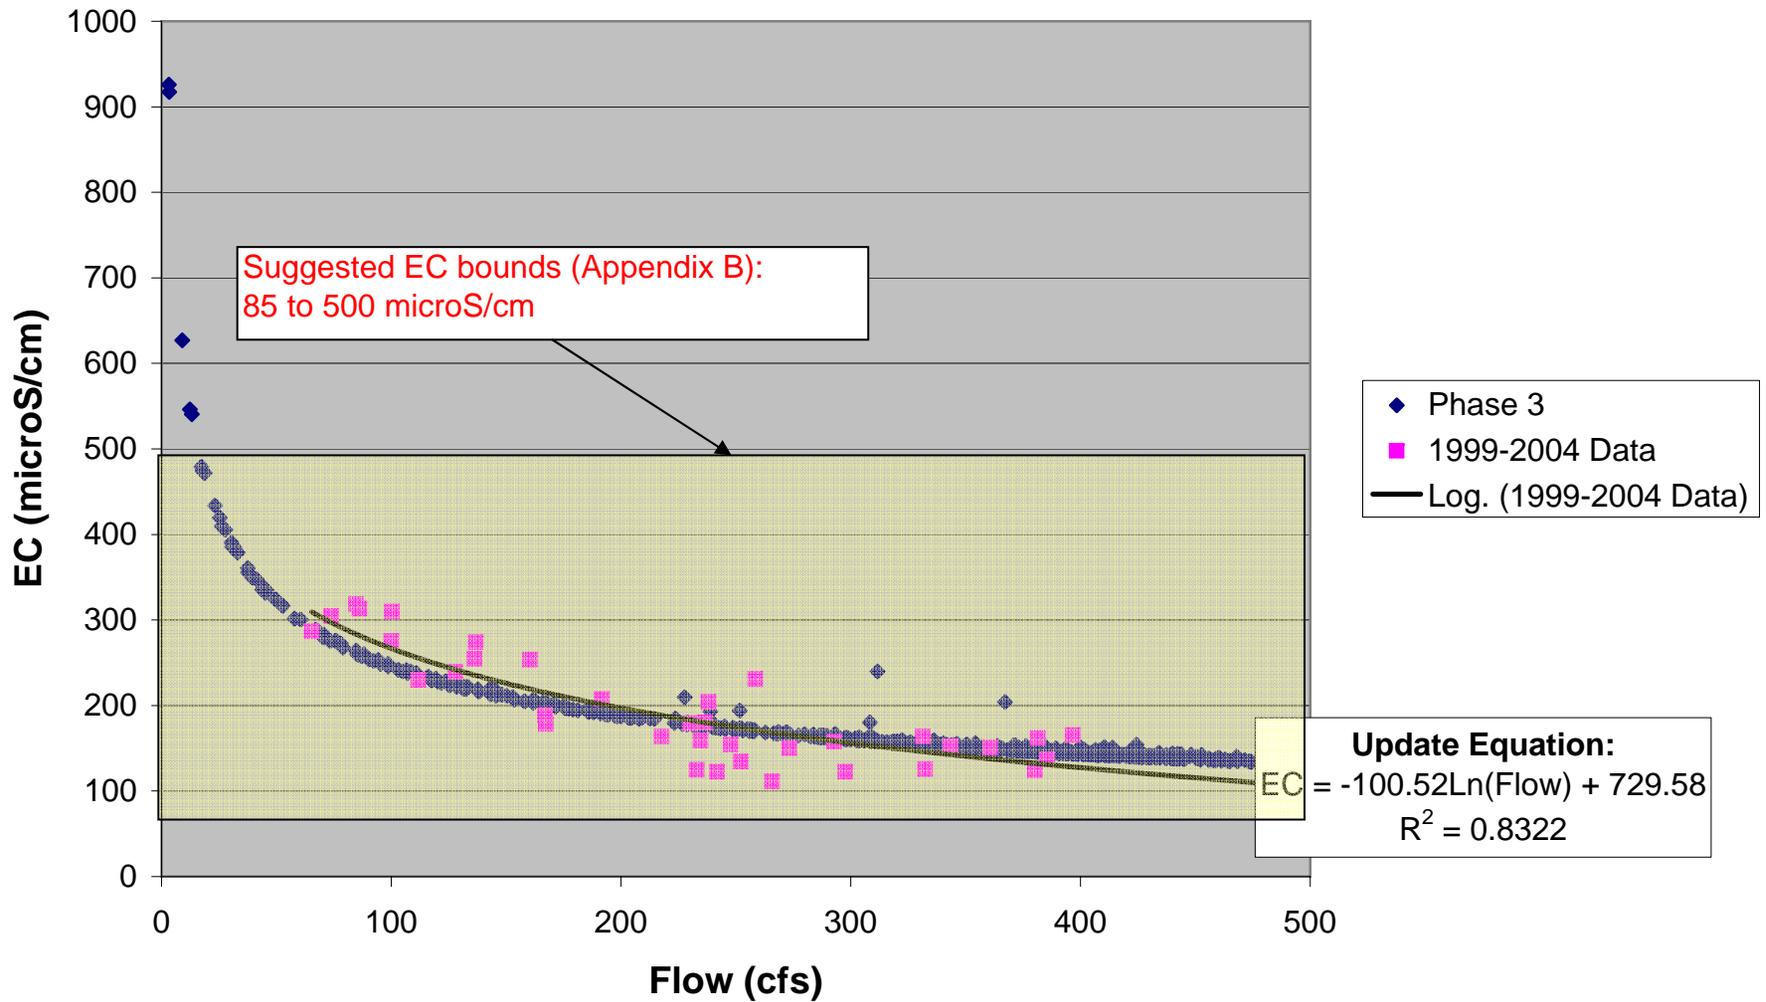
Figure 2.2
Flow-EC Boundary Condition for Merced River at Stevinson

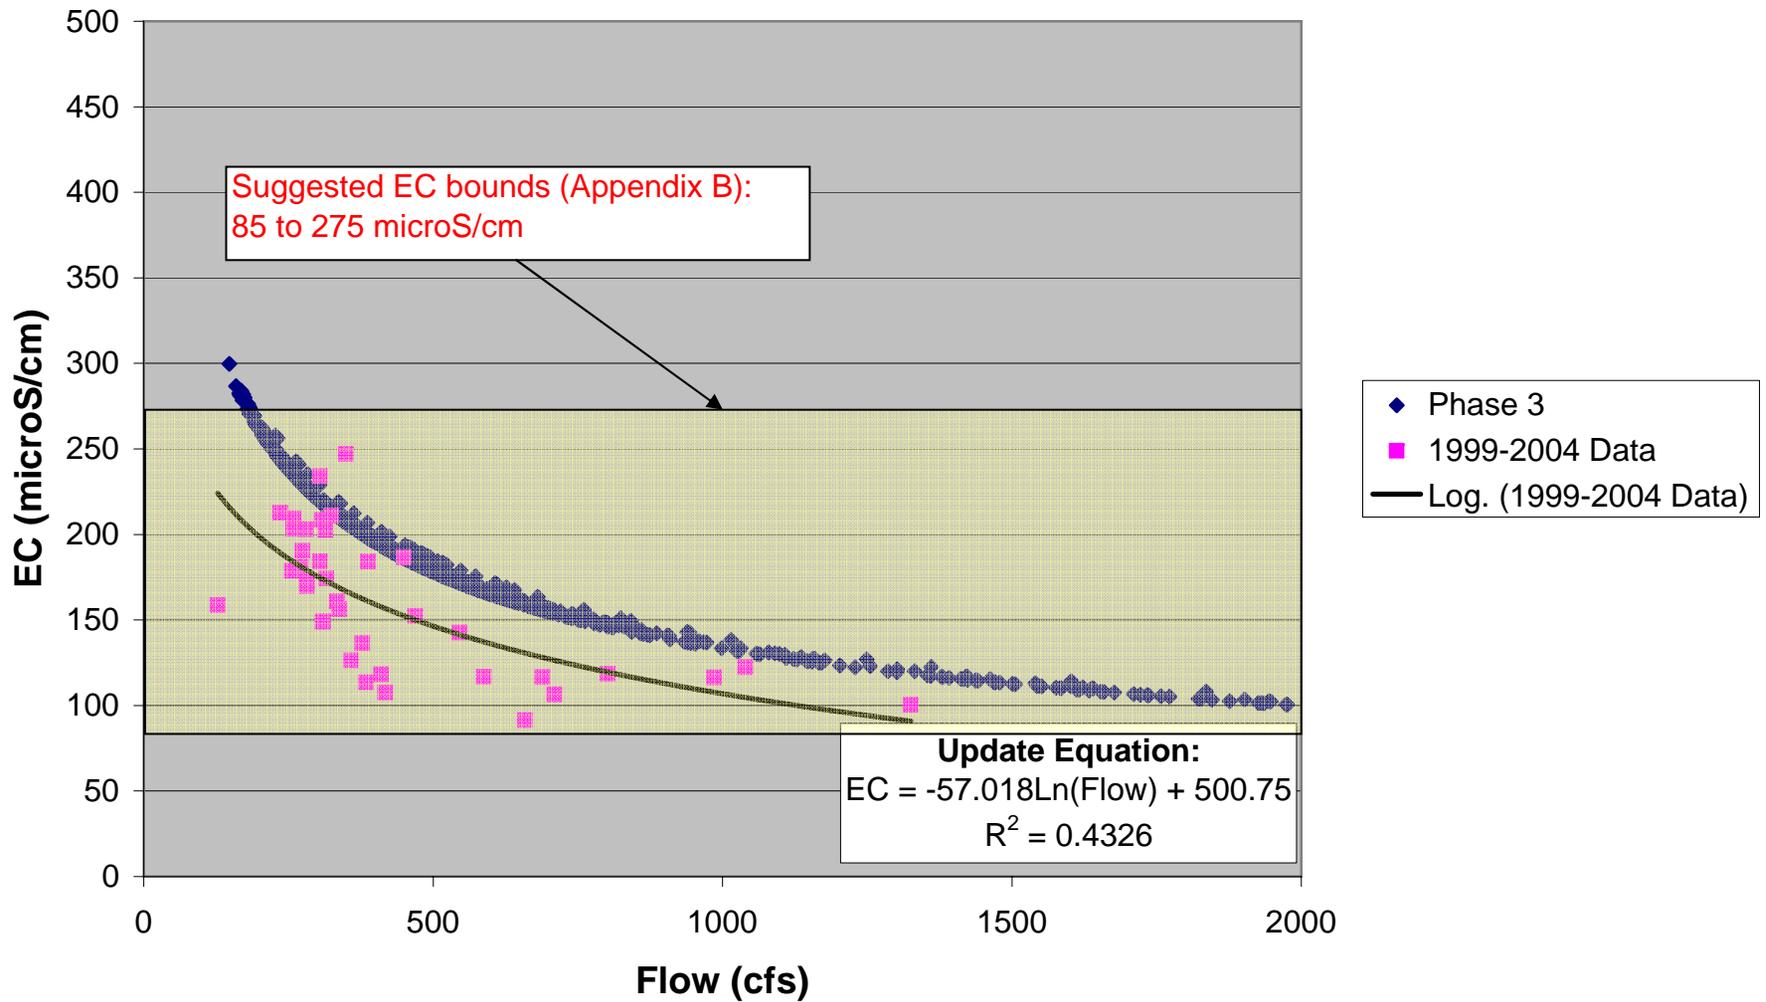
Figure 2.3
Flow-EC Boundary Condition for Tuolumne River at Modesto

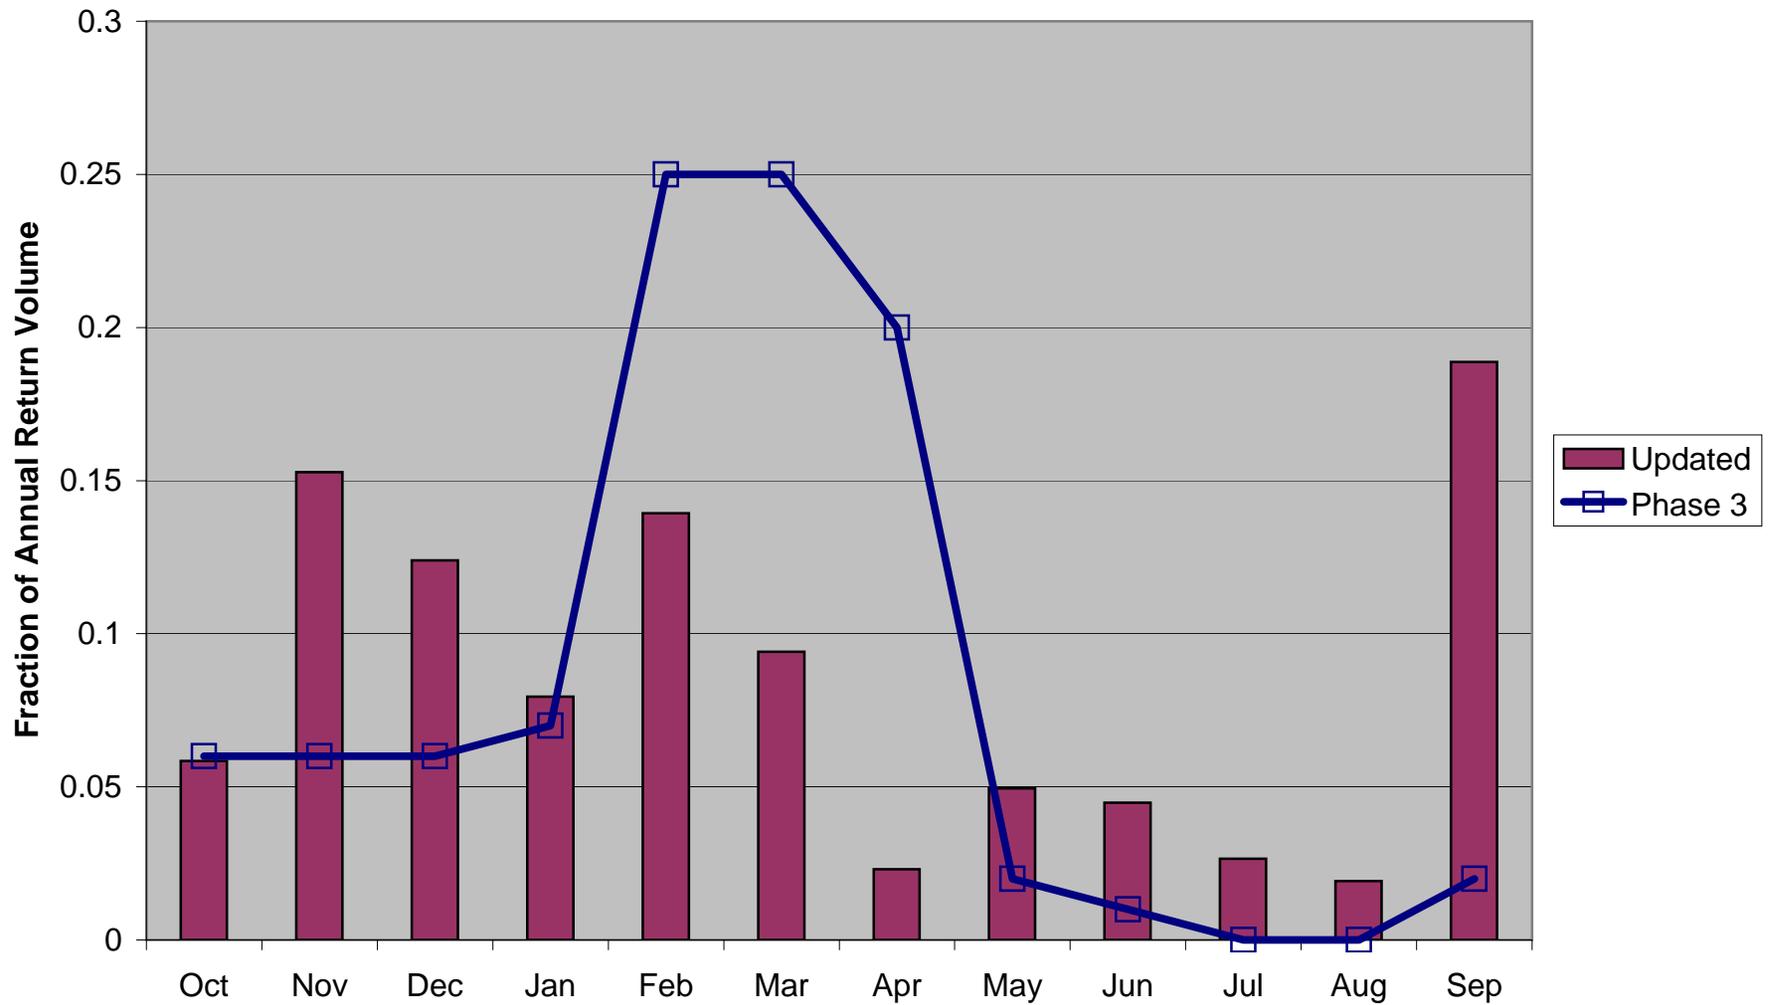
Figure 2.4
Monthly Pattern of Level 2 Refuge Return Flow through Mud/Salt Slough

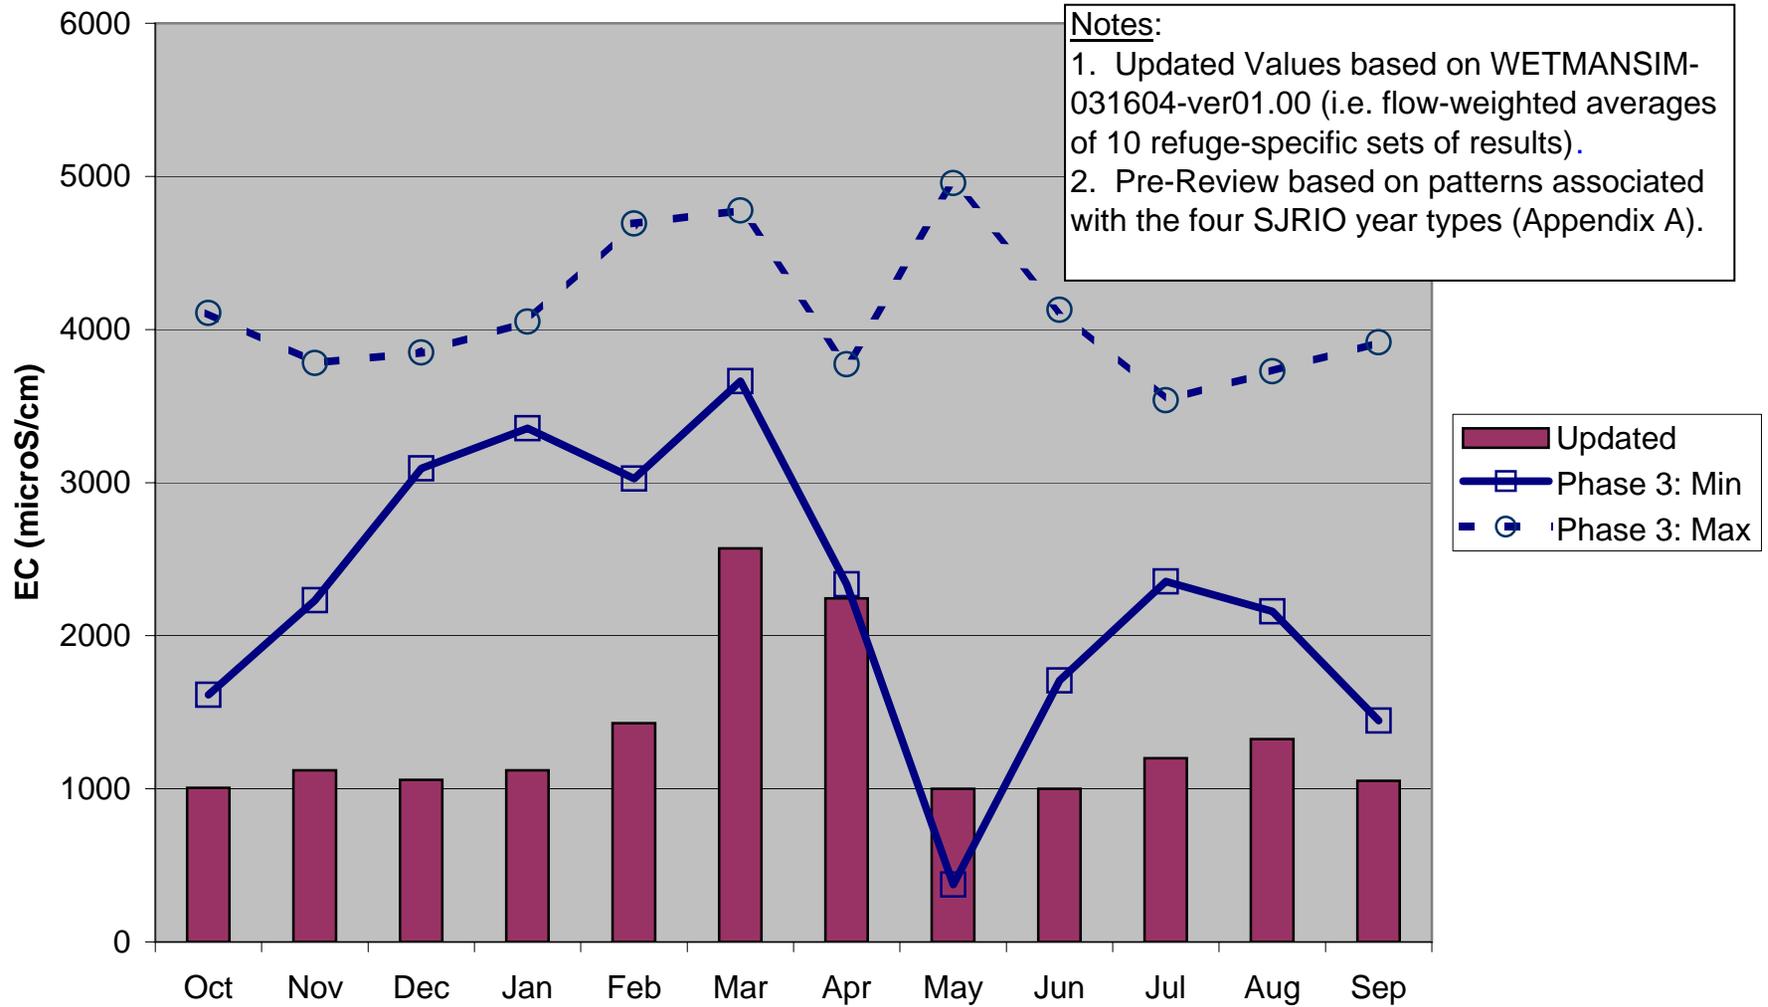
Figure 2.5
Monthly EC of Level 2 Refuge Return Flow through Mud/Salt Slough

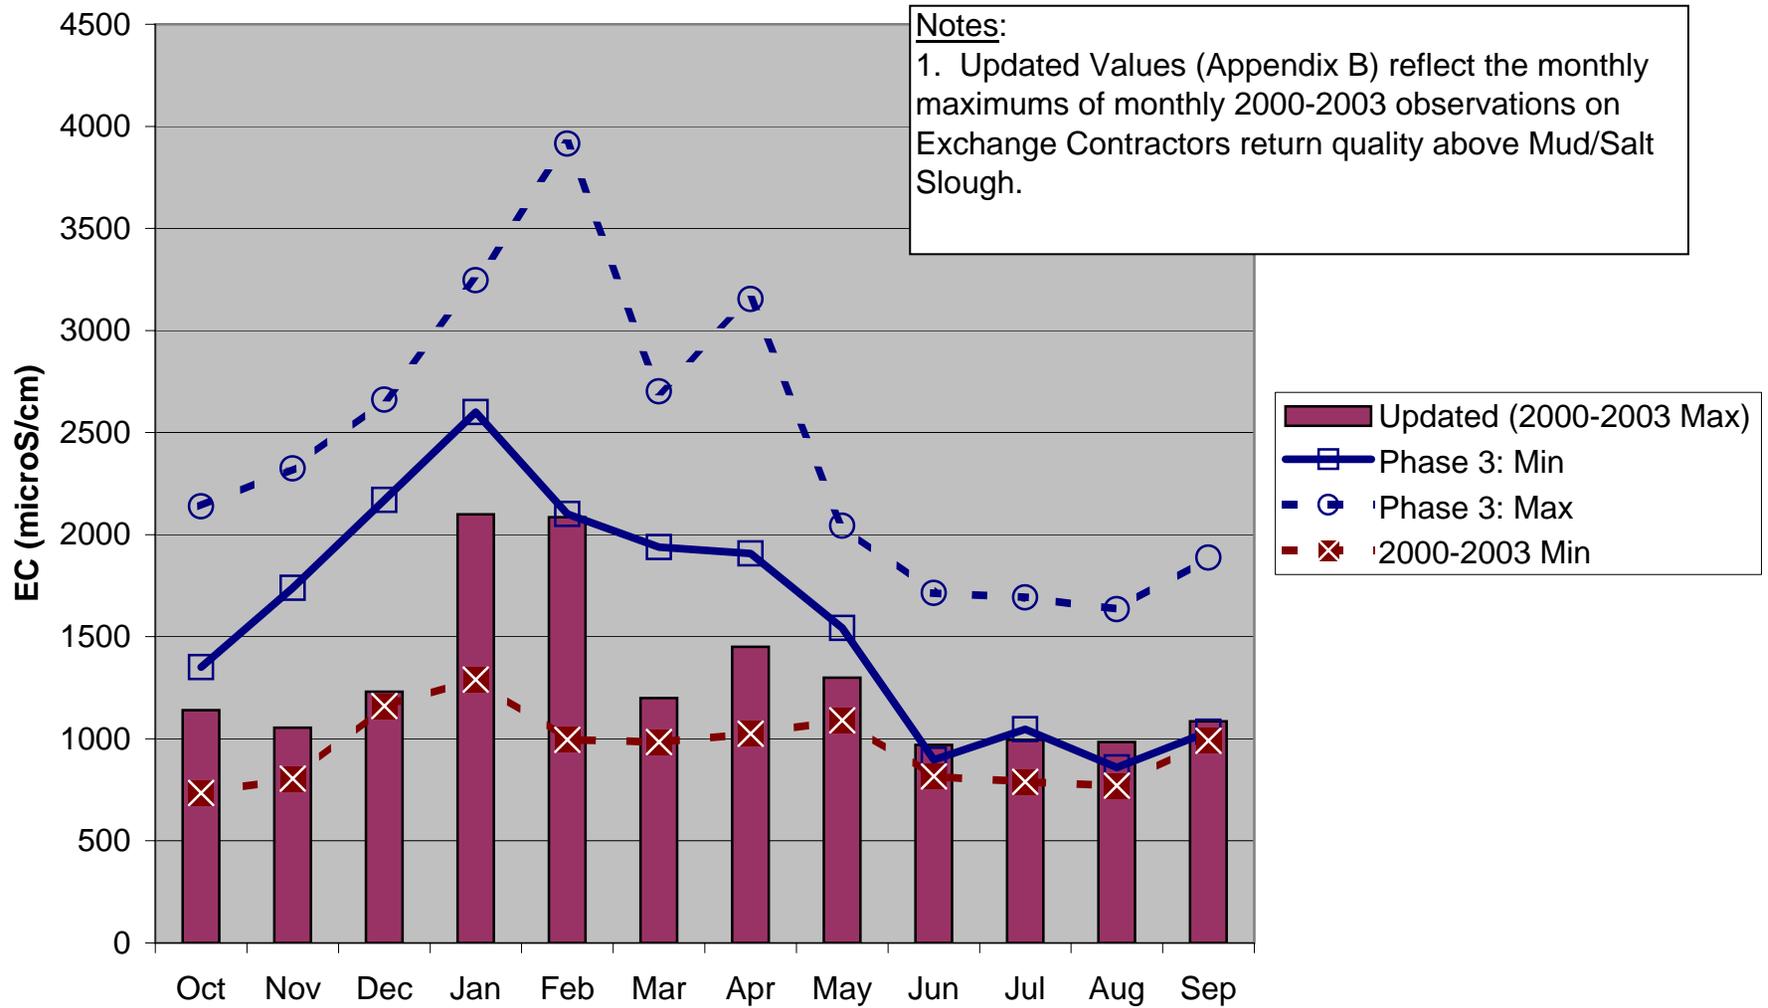
Figure 2.6
Monthly EC of Exchange Contractor Return Flow through Mud/Salt Slough

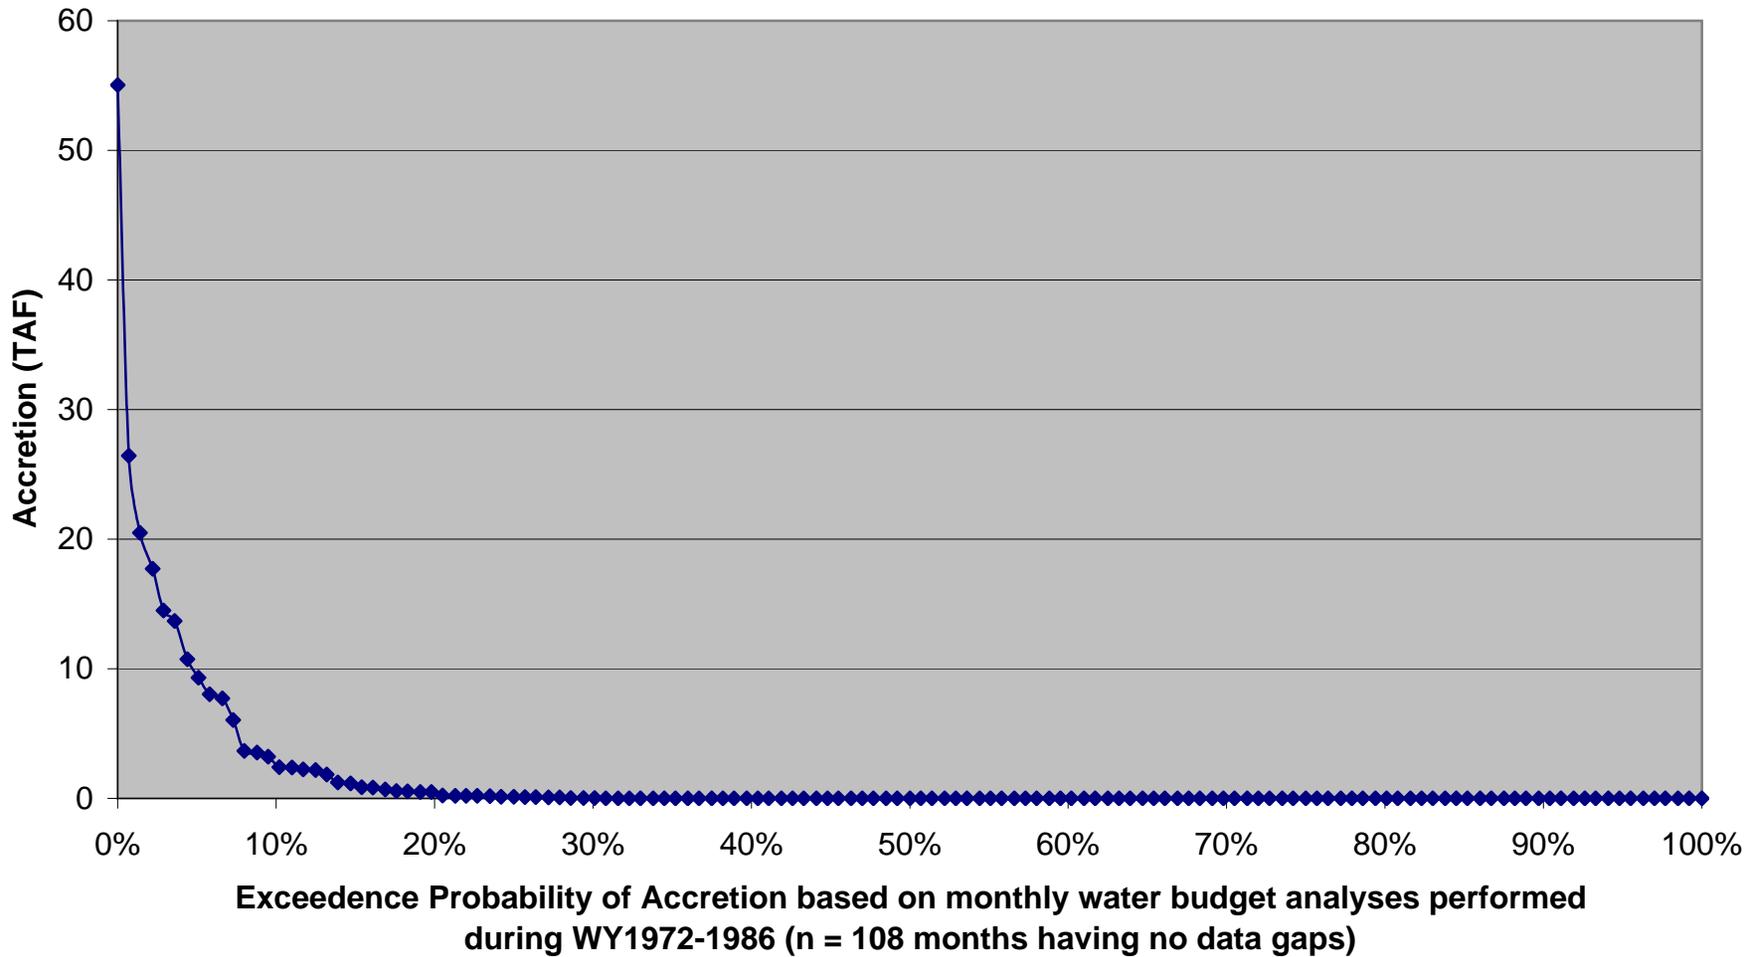
Figure 2.7:
Distribution of Bypass Structure Accretion computed at El Nido
given No Flow into Chowchilla Bypass at Head
